PENNSYLVANIA
**W. H. WALKER DAM-
MOUNTAIN LAKE RESERVOIR**

NDS ID NO. PA-00325

PHASE I INSPECTION REPORT
NATIONAL DAM INSPECTION PROGRAM

L. ROBERT KIMBALL and ASSOCIATES
CONSULTING ENGINEERS and ARCHITECTS
EBENSBURG, PENNSYLVANIA
15931

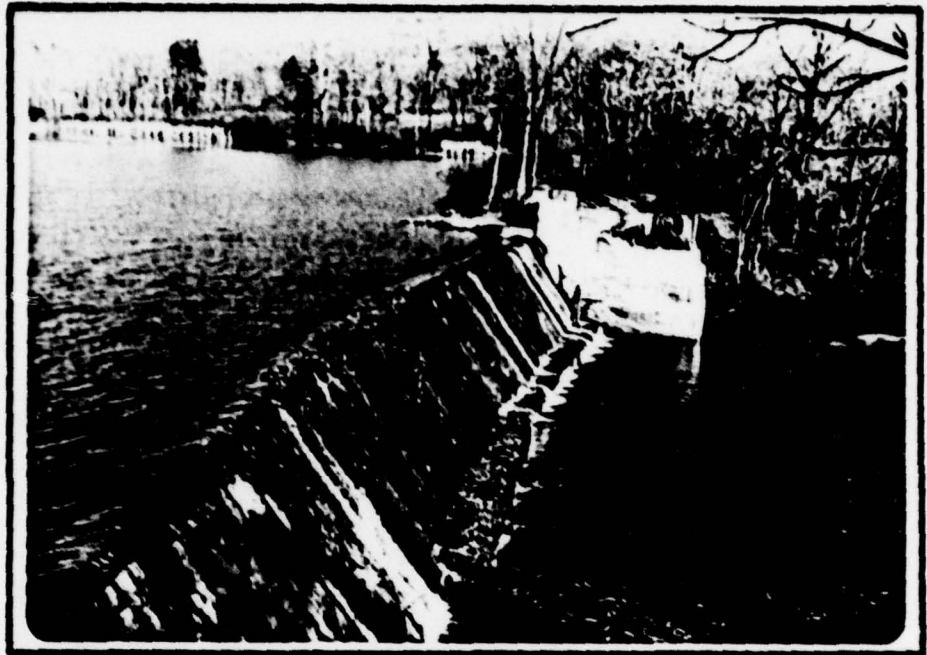
The earth embankment is in poor condition and is in need of maintenance and repair. The concrete spillway and abandoned powerhouse are deteriorating. No stability analyses have been conducted on the gravity or embankment sections. A stability analysis was conducted for this study using assumed parameters and a water level corresponding to 50% PMF indicated structural instability.

Overview of concrete spillway and abandoned power house
from right abutment.

6. The powerhouse facilities should be completely repaired or dismantled.

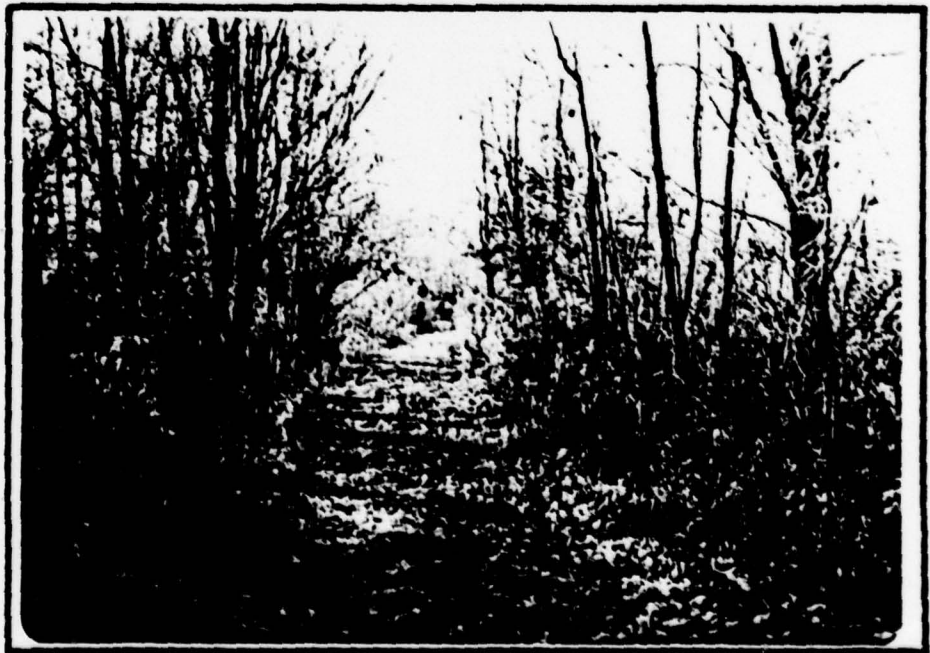
Overview of embankment section along crest from left abutment.

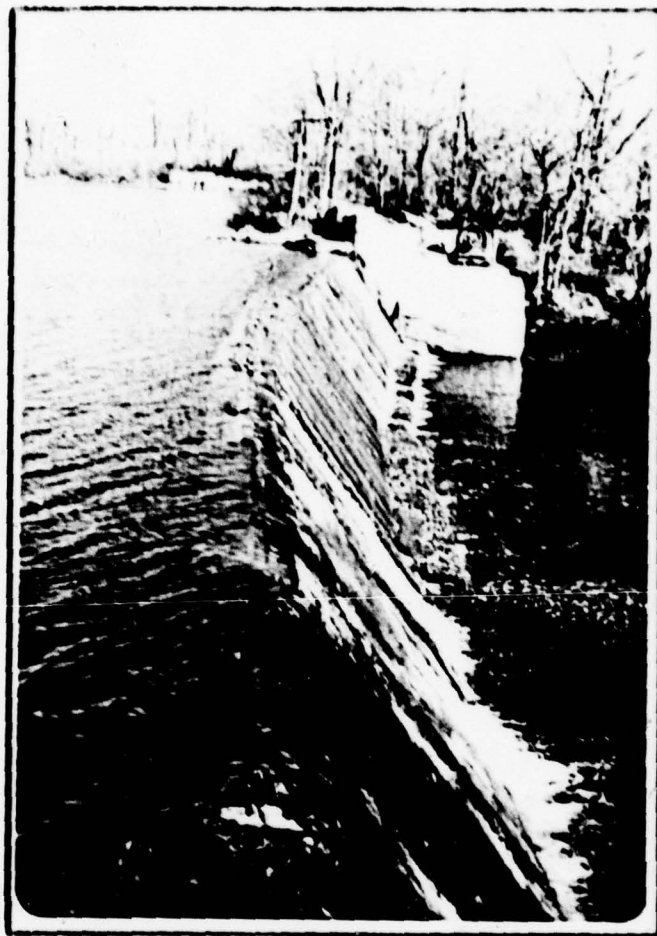
Photograph No. 1

Concrete spillway and abandoned hydroelectric power station.

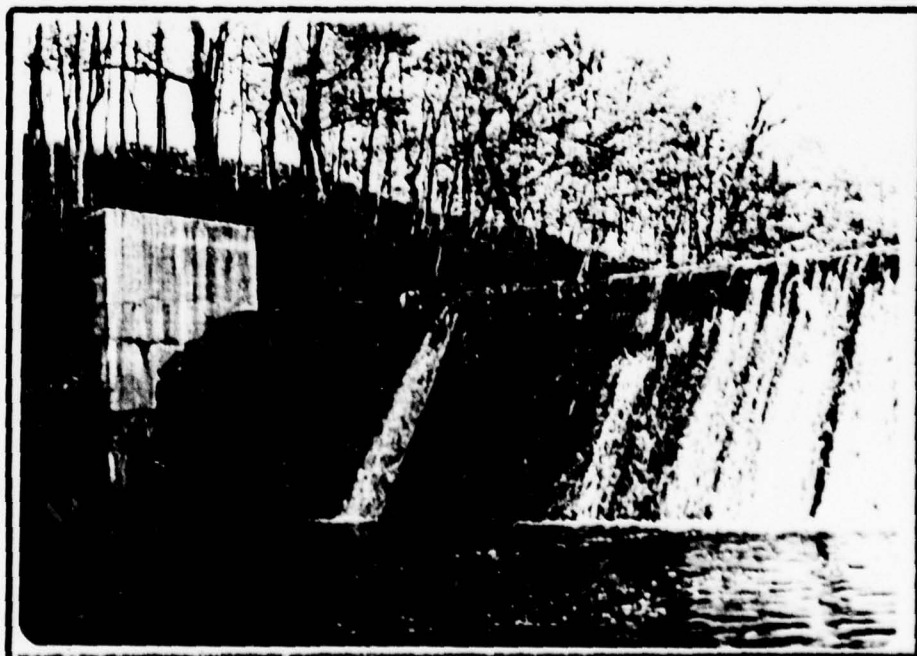
Photograph No. 2

Right abutment.
C-1

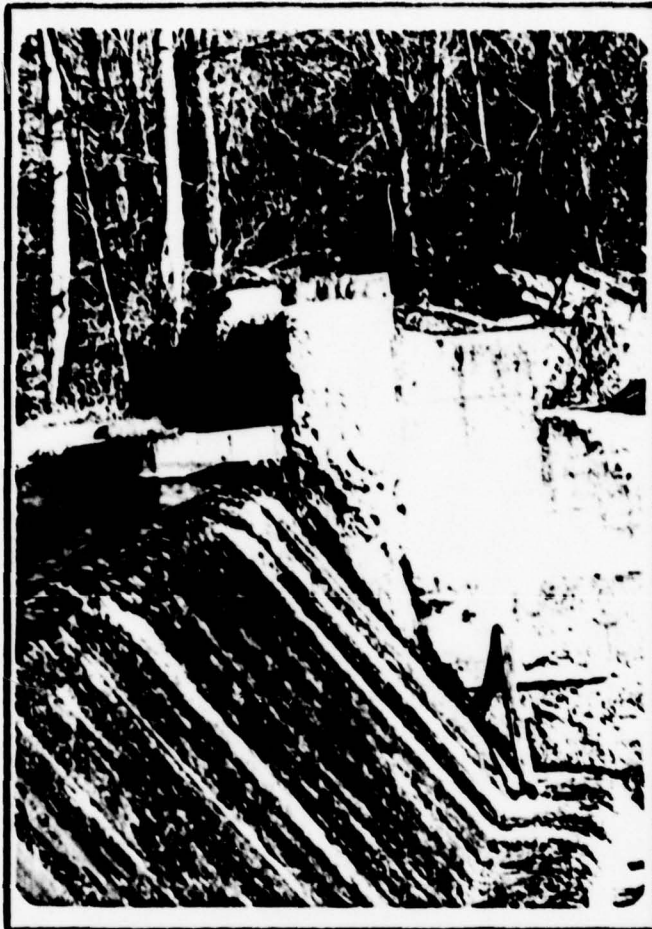
Photograph No. 3

VISUAL EXAMINATION OF	OBSERVATIONS	REMARKS OR RECOMMENDATIONS
ANY NOTICEABLE SEEPAGE	Not visible due to flow over spillway.	
STRUCTURE TO ABUTMENT/EMBANKMENT JUNCTIONS	Deterioration of concrete at left abutment.	
DRAINS	Unknown.	
WATER PASSAGES	Unknown.	
FOUNDATION	Not visible.

Junction of spillway and power house -
Deteriorated concrete.

Repairs to the concrete on the spillway and at the abutment should be performed. The possible undermining of the spillway toe should be investigated.

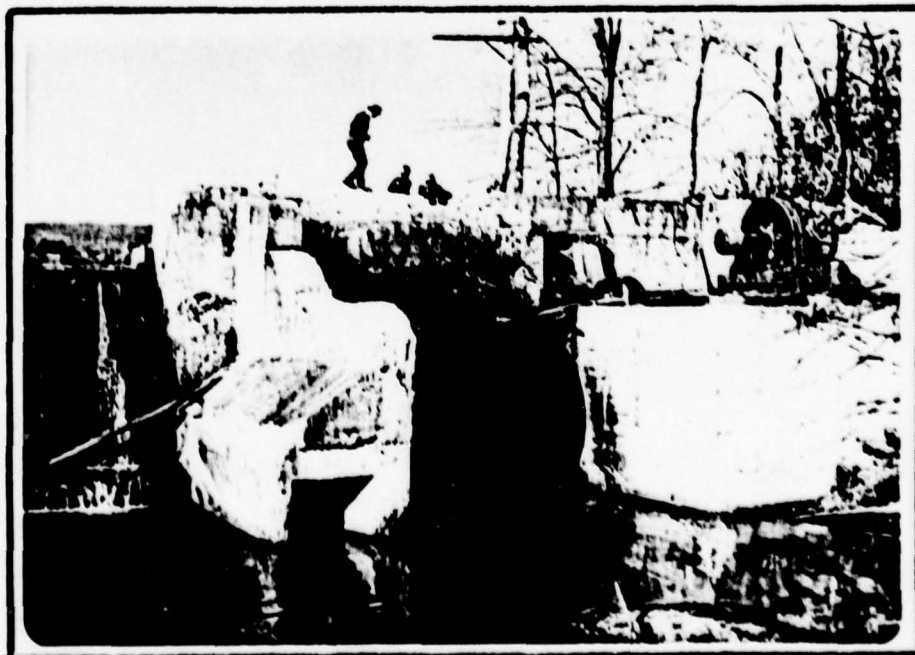
Photograph No. 4

The abandoned powerhouse is severely deteriorated. The overshoot wheel used for power generation has water seeping through it. The turbine and generator have been removed.

Abandoned power house.
C-2

7. The powerhouse facilities should be completely repaired or dismantled.

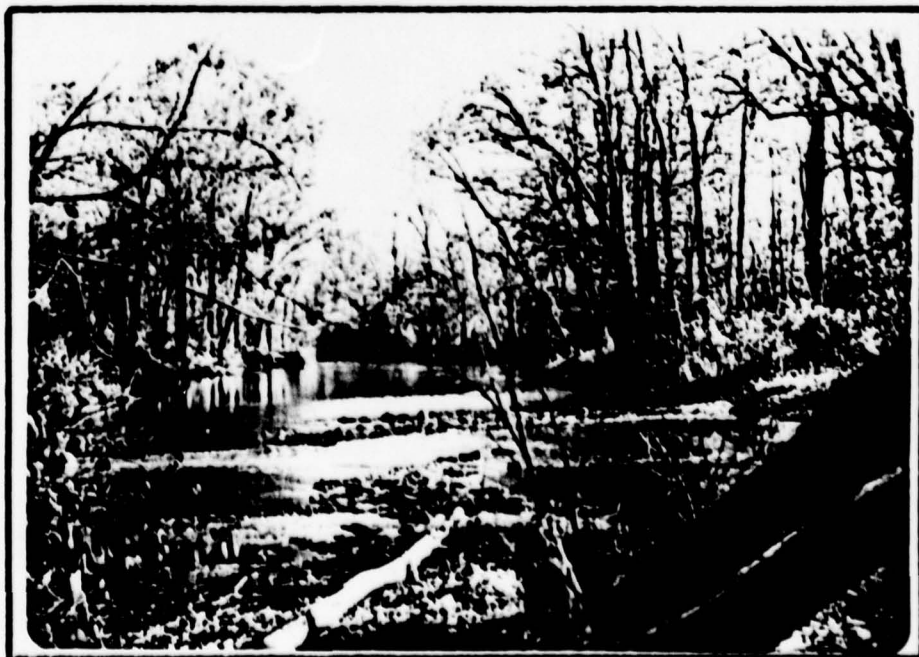
Photograph No. 6

Immediate downstream channel.
C-3

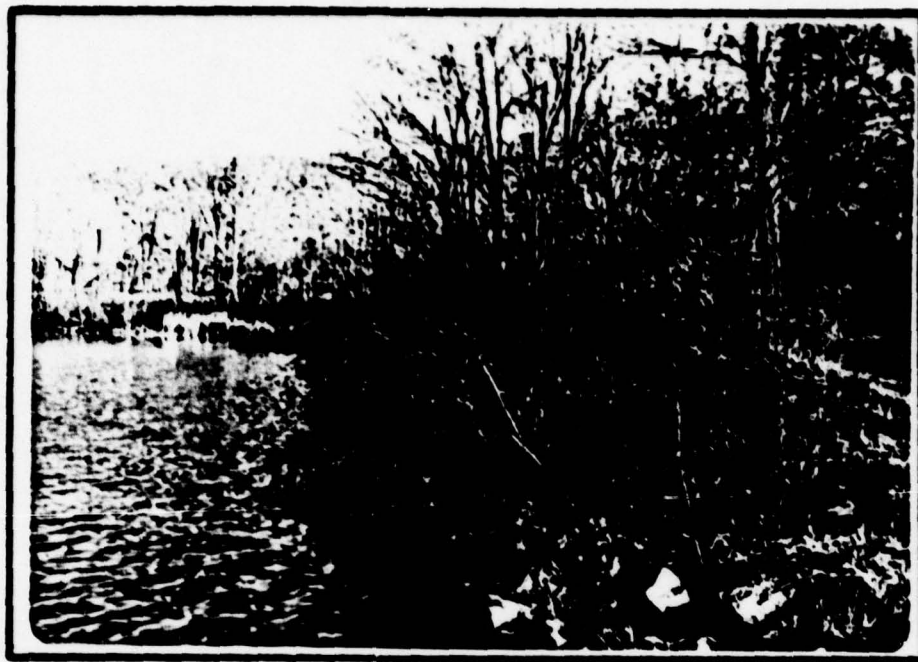
Photograph No. 7

The upstream slope was approximately 1.5H:1V with a considerable amount of vegetation in the form of trees growing on the slope. Some areas of erosion were noted. Riprap was present over most of the slope. The downstream slope averaged 2H:1V. The slope was covered with a very thick growth of trees and brush. There is some erosion near the toe of the embankment.

Upstream slope of earth embankment.

6. Riprap should be repaired and new riprap placed on the upstream slope where none exists.

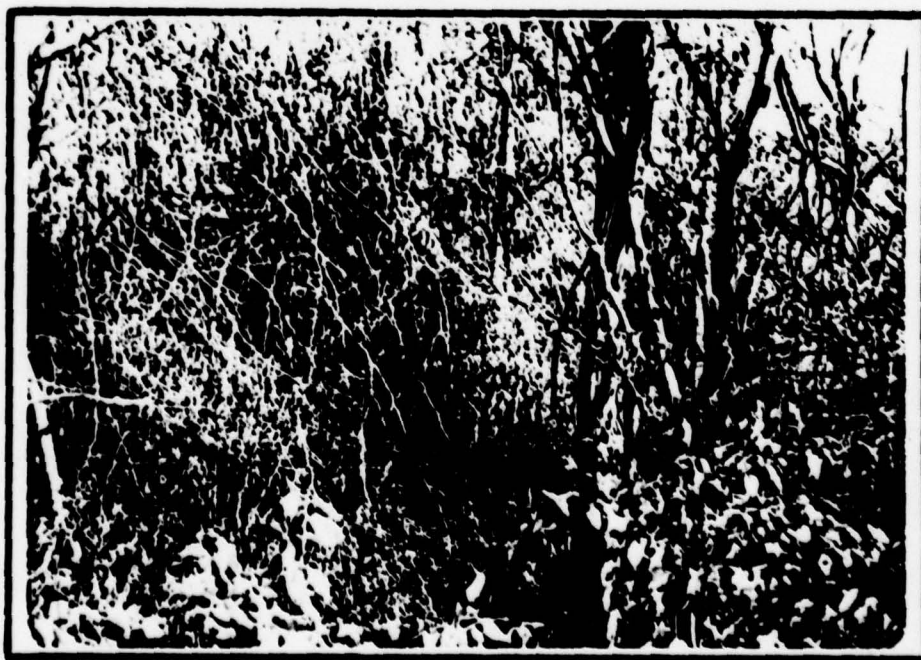
Photograph No. 8

At and beyond the toe of the embankment there is a pond of water. The source of this water was not determined. At the western end of the pond water was flowing from the pond to the creek.

Downstream slope of earth embankment.

2. The water ponded at the toe should be drained and a weir installed and if there is flow, the flow should be measured and recorded and the turbidity observed. If flow increases or water is turbid a detailed study should be made at once and remedial measures taken.
